## 2. Defect Photos and Details

### 2.1 B2 parking lot

#### B2 parking lot-1

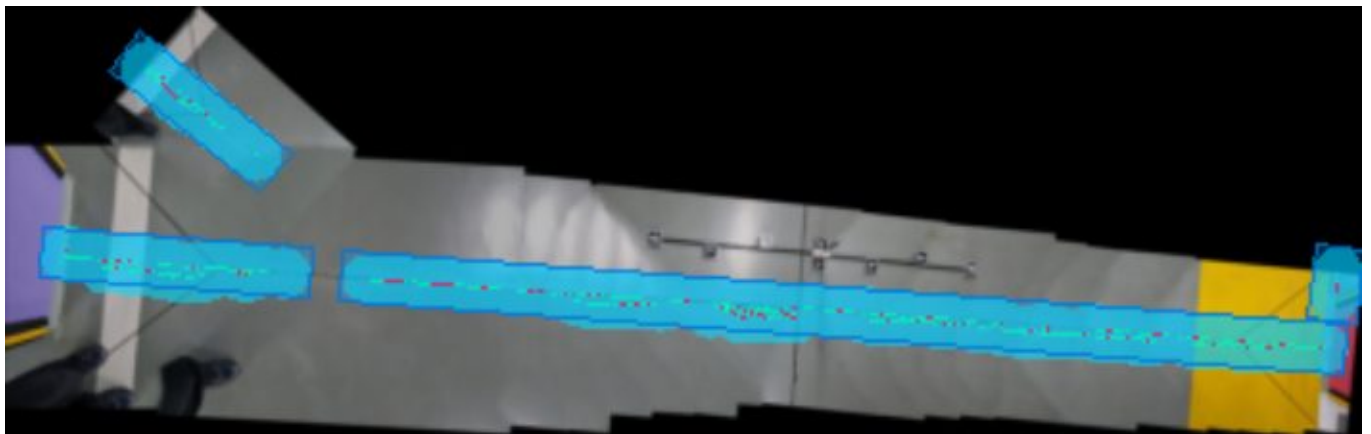
| Photo no. | 1 |

| Location | B2 parking lot |
| Surface | Floor |
| Defect type | Crack |
| Crack width $\geq 0.3$ mm | 0 |
| Crack length (m) | 11.77 |
| Max crack width (mm) | 14.09 |
| Total repair area (m <sup>2</sup> ) | 2.80 |

| Expected repair method | Epoxy injection |
